# Mountain Valley Watch

## Erosion Control Survey

<b>Survey Date</b>	08/02/2018 7:30 PM
<b>Construction Stage</b>	active construction

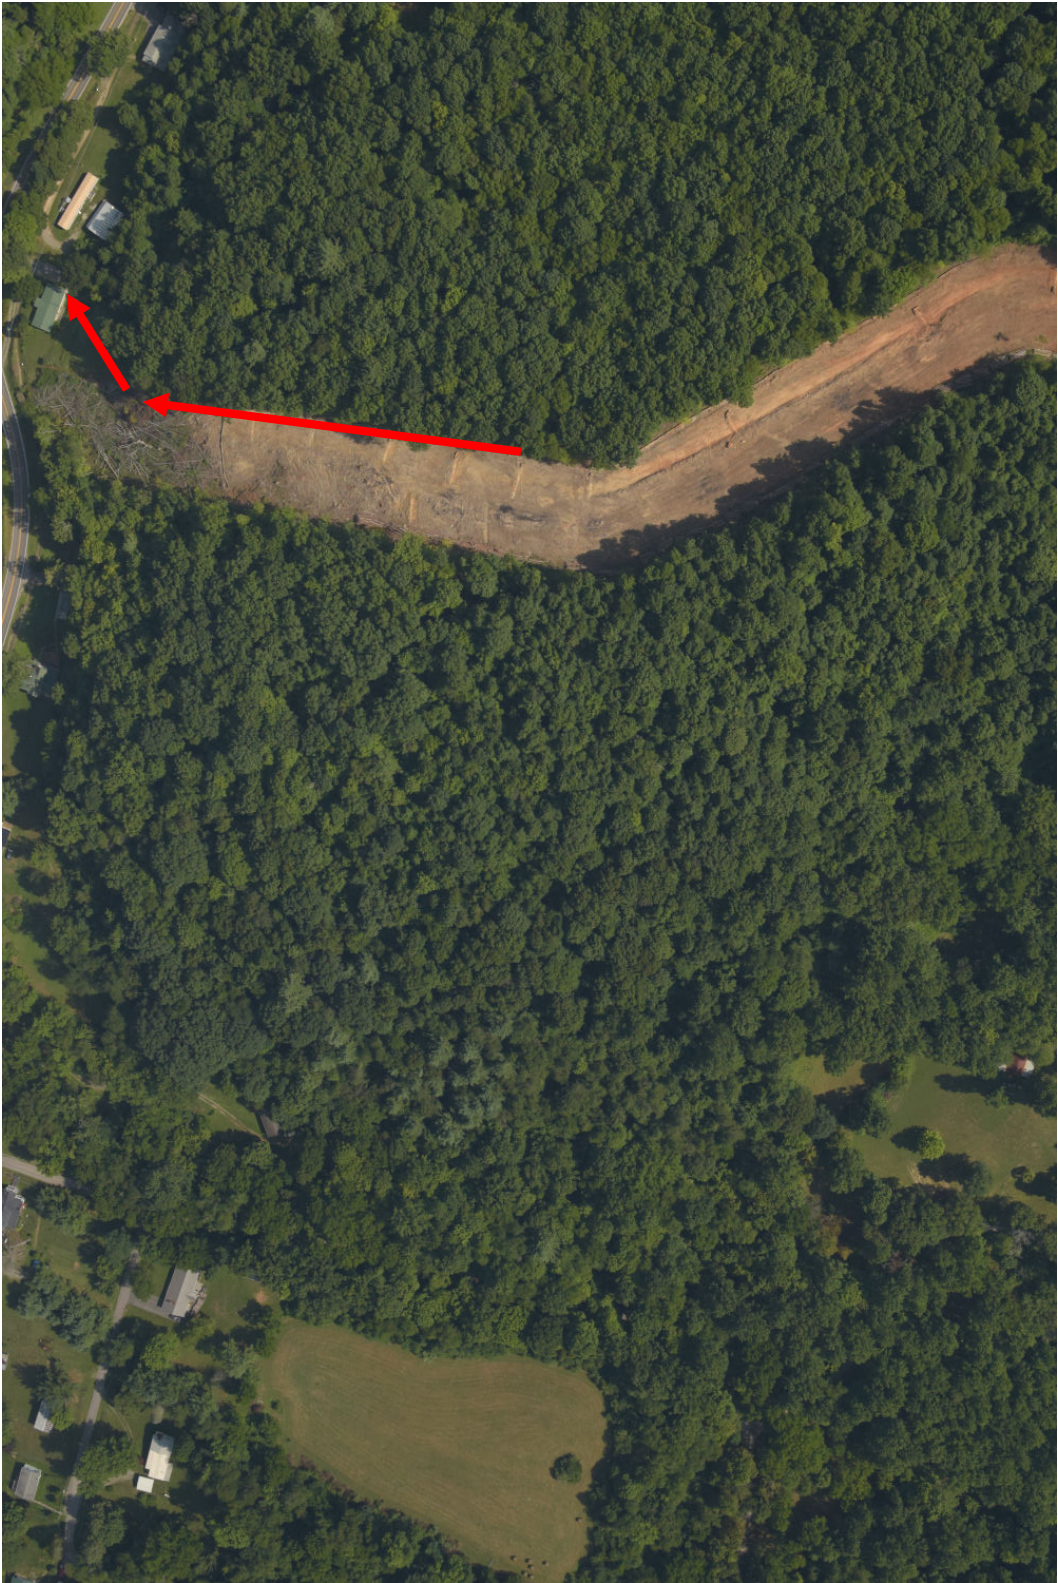
Aerial

evidence of sediment leaving the construction site, evidence of erosion at the site  
Sediment plume, Stream water discolored, Increased sediment deposition

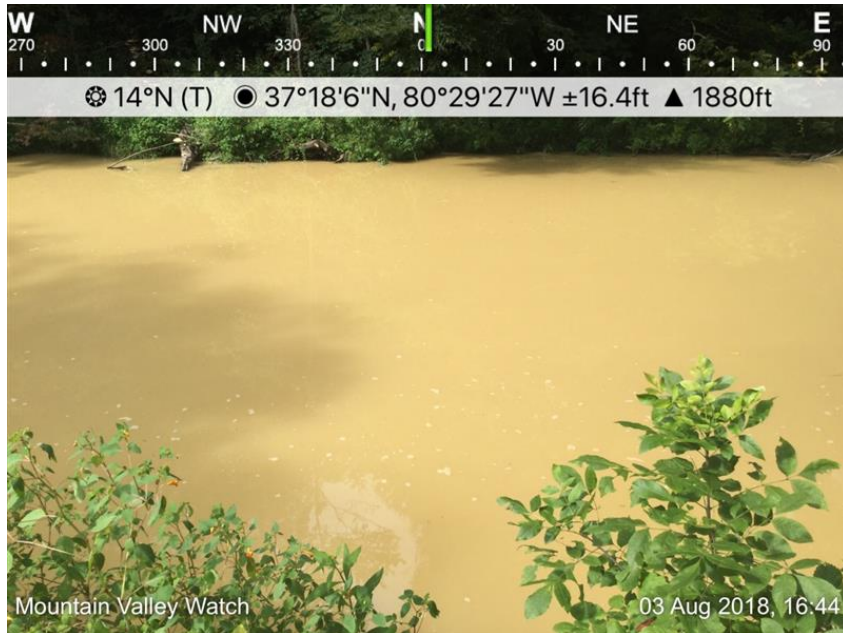
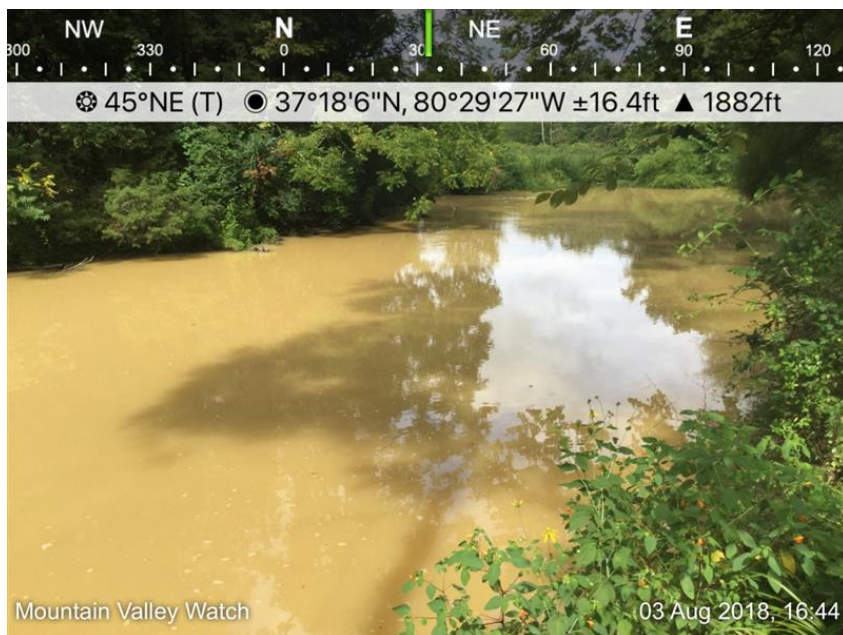
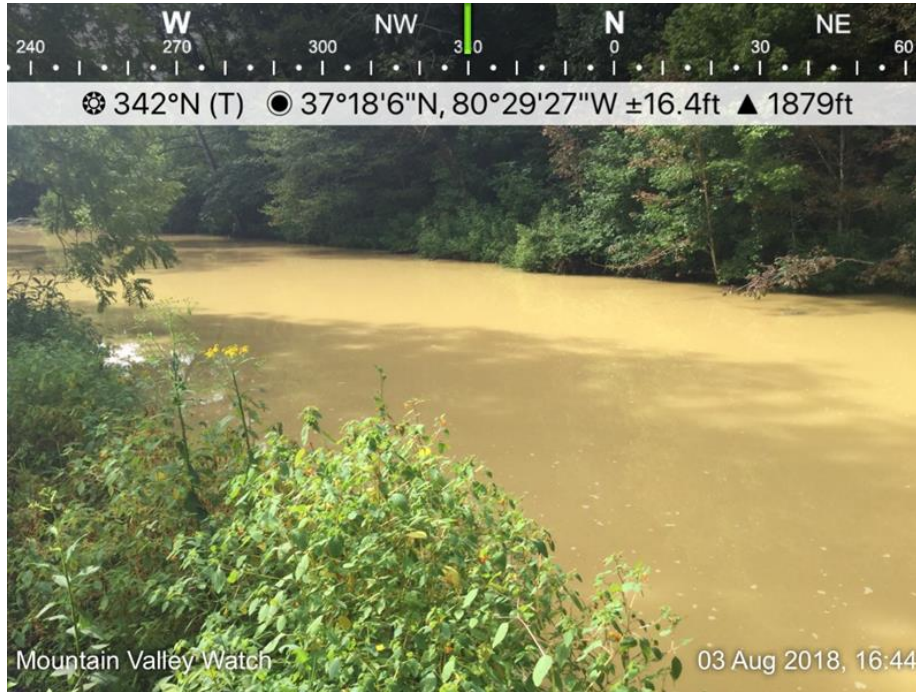
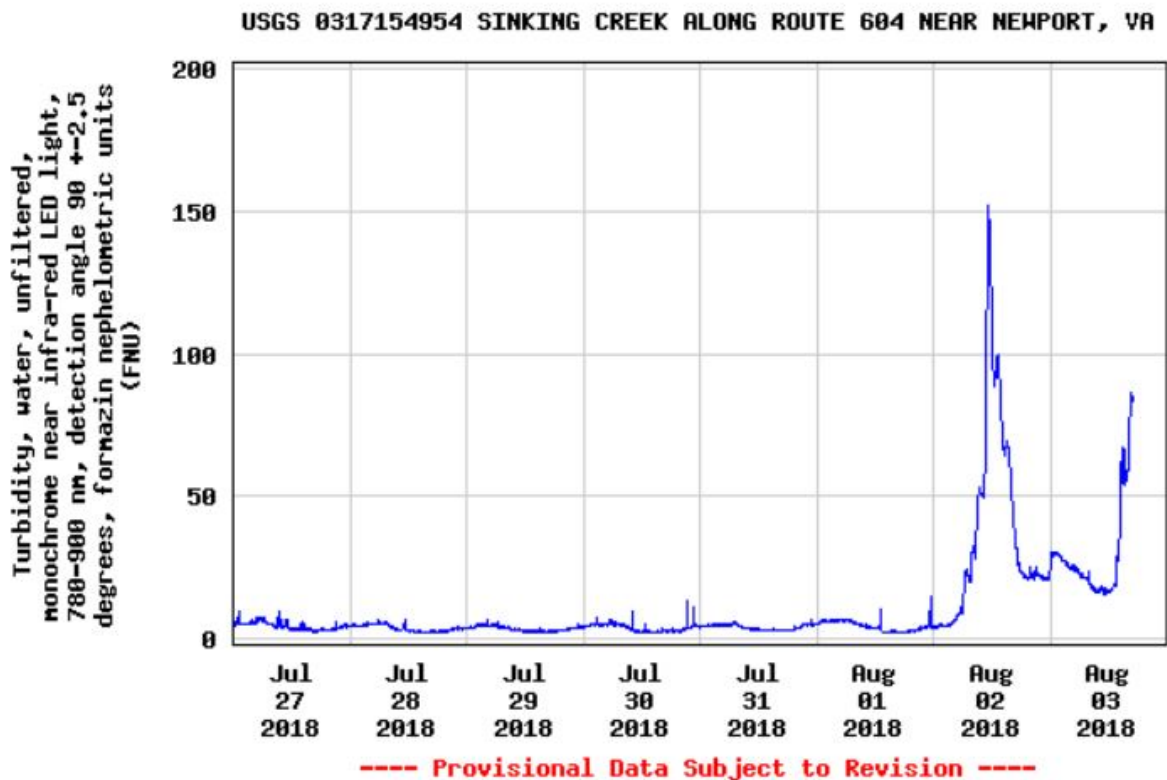
General conditions of Sinking Creek on August 3, 2018 downstream from several areas of runoff into tributaries which run into Sinking Creek and less than a mile upstream from USGS data collection point on Sinking Creek.
